ANALYSIS OF CORONA DISCHARGE AND EARTH FAULT ON 33KV OVERHEADLINE

S.K.Vjithanantha, S.Vengadesan, S. Venkatraakavan, R.M.H.L.Thushara.

Supervised By: Prof. J. R. Lucas

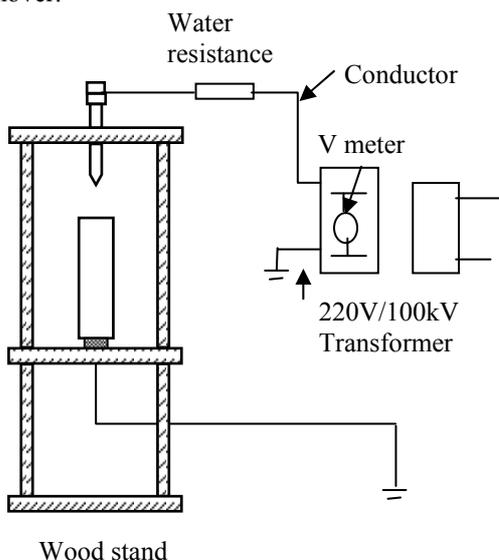
Fig 3.6 Equipment set up in the high voltage laboratory to observe the influence of concrete covering on flashover.

From the following table we can say when if the concrete covering thickness is high flashover voltage also high.

In 33kV line voltage is constant when concrete covering reduces it will easily lead to flashover

Thickness (X mm)	Voltmeter Reading (V)	Secondary Voltage (kV)
0	32	14.55
5	38	17.27
10	40	18.18

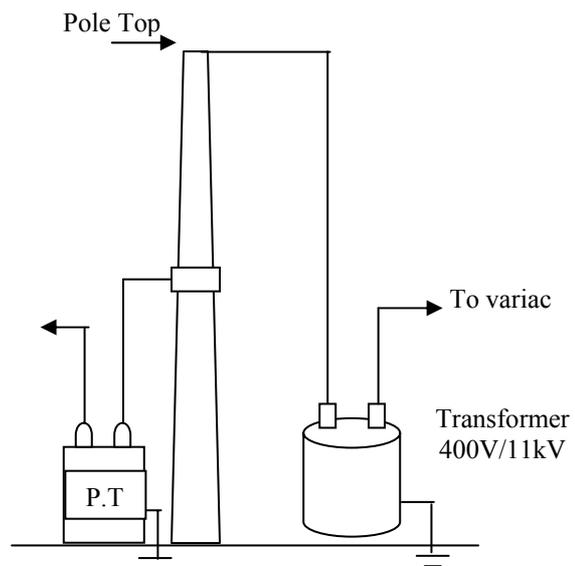
Fig. 4.1 Application of test voltage to pole

- * Voltage distribution is almost a constant along the pole 10m from the ground.
- * Almost all the applied voltage appears on the top region of the pole.
- * Concrete layer of the pole top burn out at the 840V.

Using above voltage distribution one can find out the pole impedance behavior at different voltages and this experiment reveals a equivalent model for a ideal reinforced pole.
